DEFENDANT BEXAR COUNTY AND DEPUTY MOLINA'S  
MOTION TO STRIKE PLAINTIFF'S EXPERT

**RICARDO J. PALACIOS SR. EXPERT REPORT**

## Palacios Accident Reconstruction, LLC

**Date:** September 23, 2024

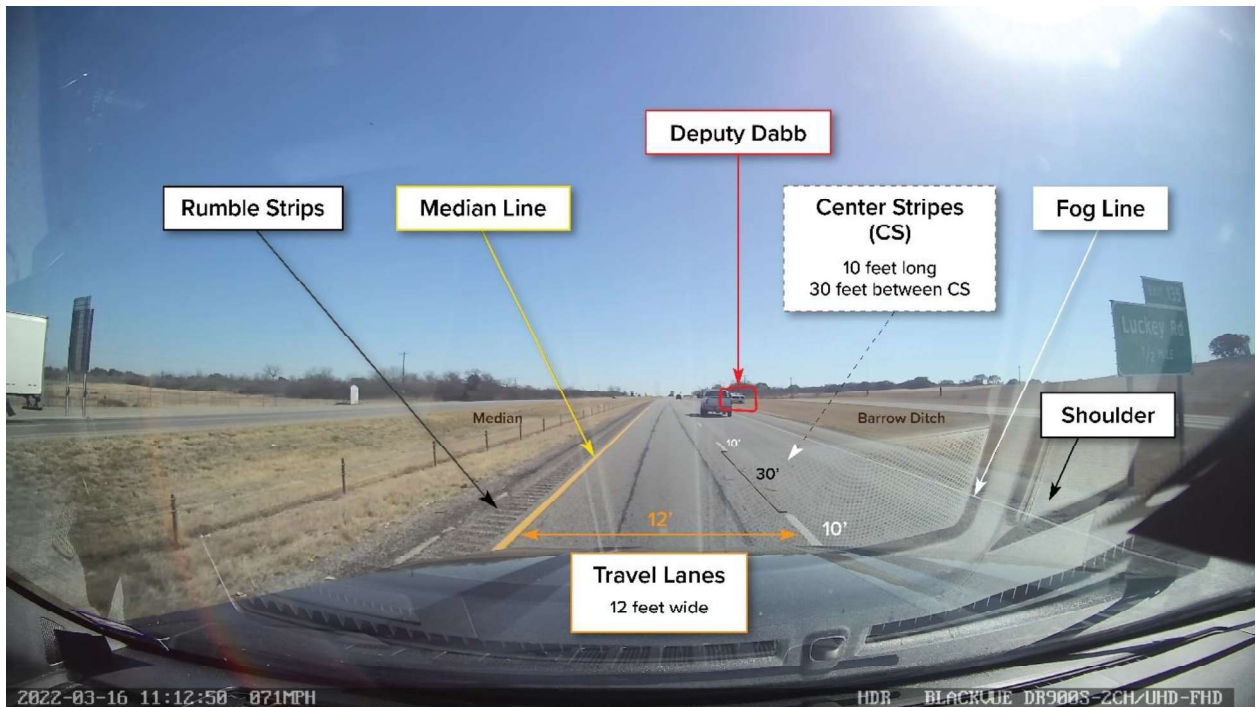
35. Using footage from Mr. Schott's dashboard camera from March 16, 2022, observations from my site visit, and my own familiarity of the structure of Texas highways, I captured the following information about the portion of the highway that Mr. Schott was driving on when he passed Deputy Babb:

36. The correct term for the yellow line on the outside of the left travel lane is “median line.”
37. The correct term for the white line on the outside of the right travel line is “fog line.”

38. The term “shoulder” only refers to the portion of the roadway to the right of the roadway.
39. Deputy Babb incorrectly referred to the median line as the fog line. To avoid confusion, I simply refer to the median line as the yellow line.

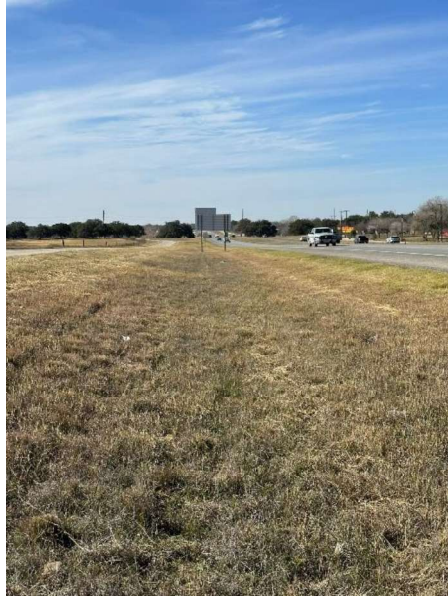
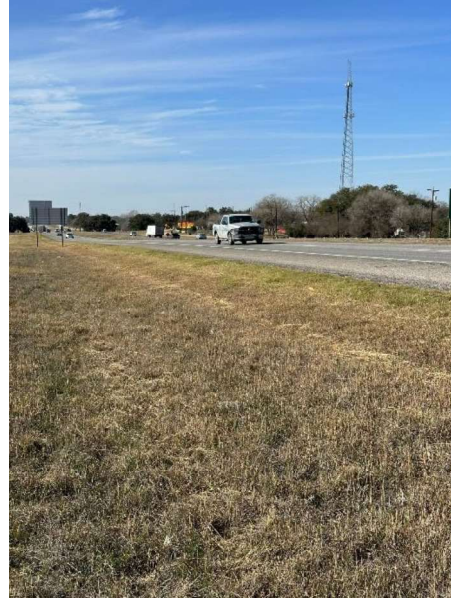
42. On March 16, 2022, Deputy Babb was parked in the barrow ditch between the shoulder of I-35 Northbound and a frontage road that runs parallel to I-35 for that portion of the highway. The barrow ditch slopes downward from I-35, bottoms into a small valley, before sloping up to the frontage road. The middle of the barrow ditch is lower while the portions of the ditch near I-35 Northbound and the frontage road are higher.

43. The structure of the barrow ditch and the place where Deputy Babb parked his patrol vehicle mean that the wheels of Deputy Babb's patrol vehicle were below the plane of the I-35 Northbound roadway and that Deputy Babb's patrol vehicle would have been angled slightly up.
44. Mr. Schott's dashboard camera footage confirms my conclusions that Deputy Babb's patrol car was lower than the I-35 Northbound roadway with the front tires slightly higher than the back tires.

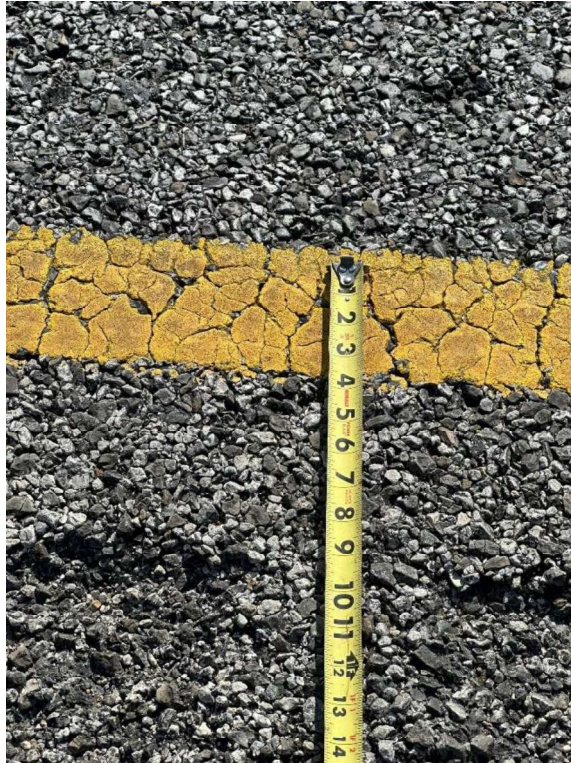
47. There are approximately 9 inches from the side of the yellow line on the inside of the left lane to the rumble strip.

48. The tires on Mr. Schott's truck were 10.8 inches wide.
49. If Mr. Schott's tires had fully crossed the yellow line, the tires would have hit the rumble strip. There was not enough space between the outside of the yellow line and the rumble strip for Mr. Schott's tires to travel without running on the rumble strip.

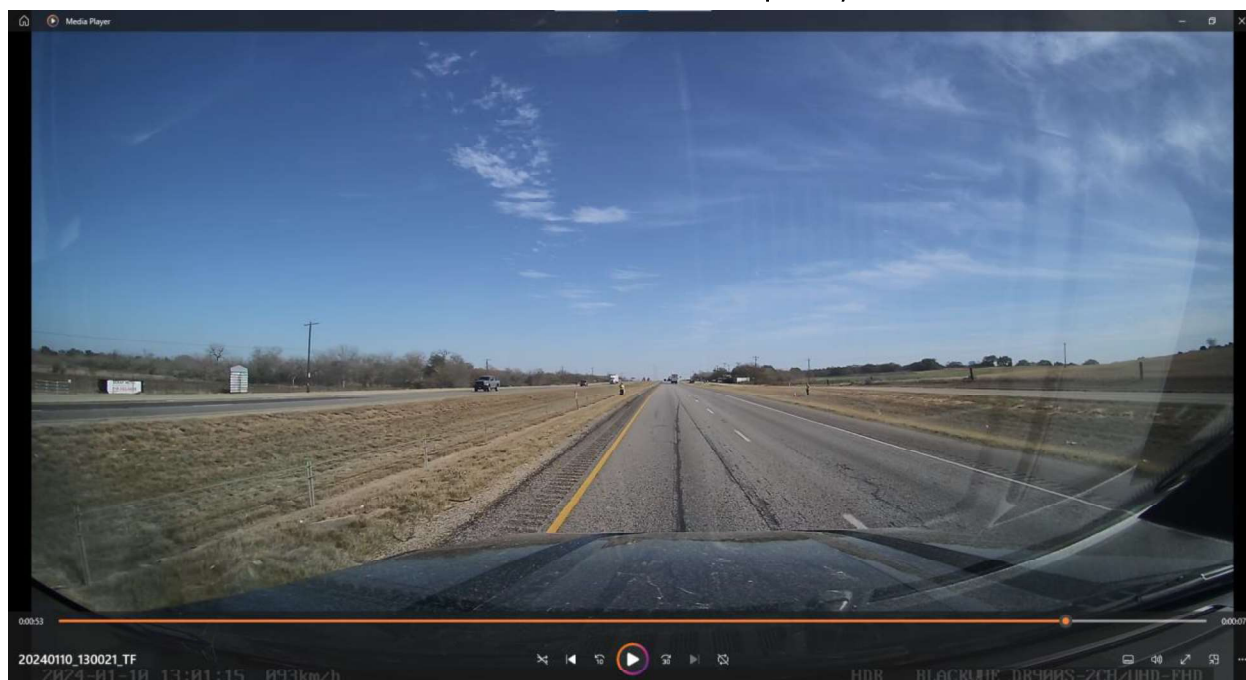
a. Pass 1: View when Mr. Schott's truck is completely in the left travel lane

55. I identified that when Mr. Schott's truck is within the travel lane, the yellow line appears to the left of the left indentation in the hood of Mr. Schott's truck. When Mr. Schott's truck tires touch the yellow line, the yellow line appears in the center of the left indentation in the hood of Mr. Schott's truck. When the tires of Mr. Schott's truck cross

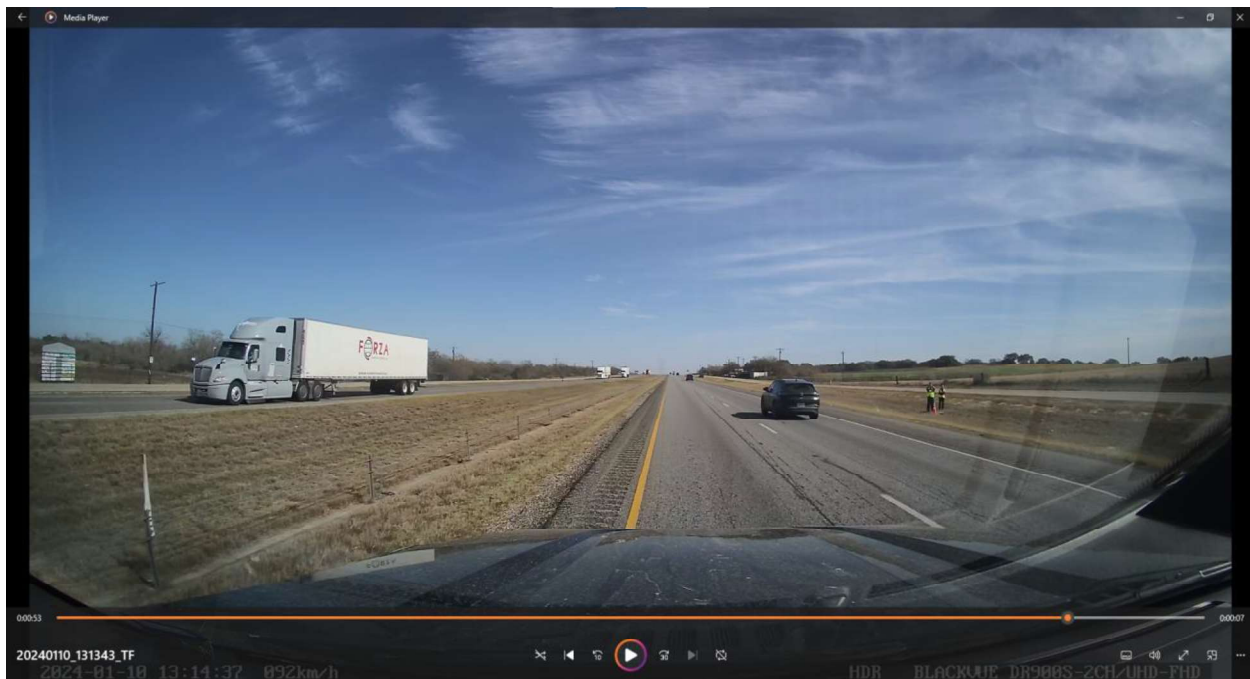
c. Pass 3: View when the tires of Mr. Schott's truck cross the yellow line

the yellow line, the yellow line appears to the right of the left indentation in the hood of Mr. Schott's truck.

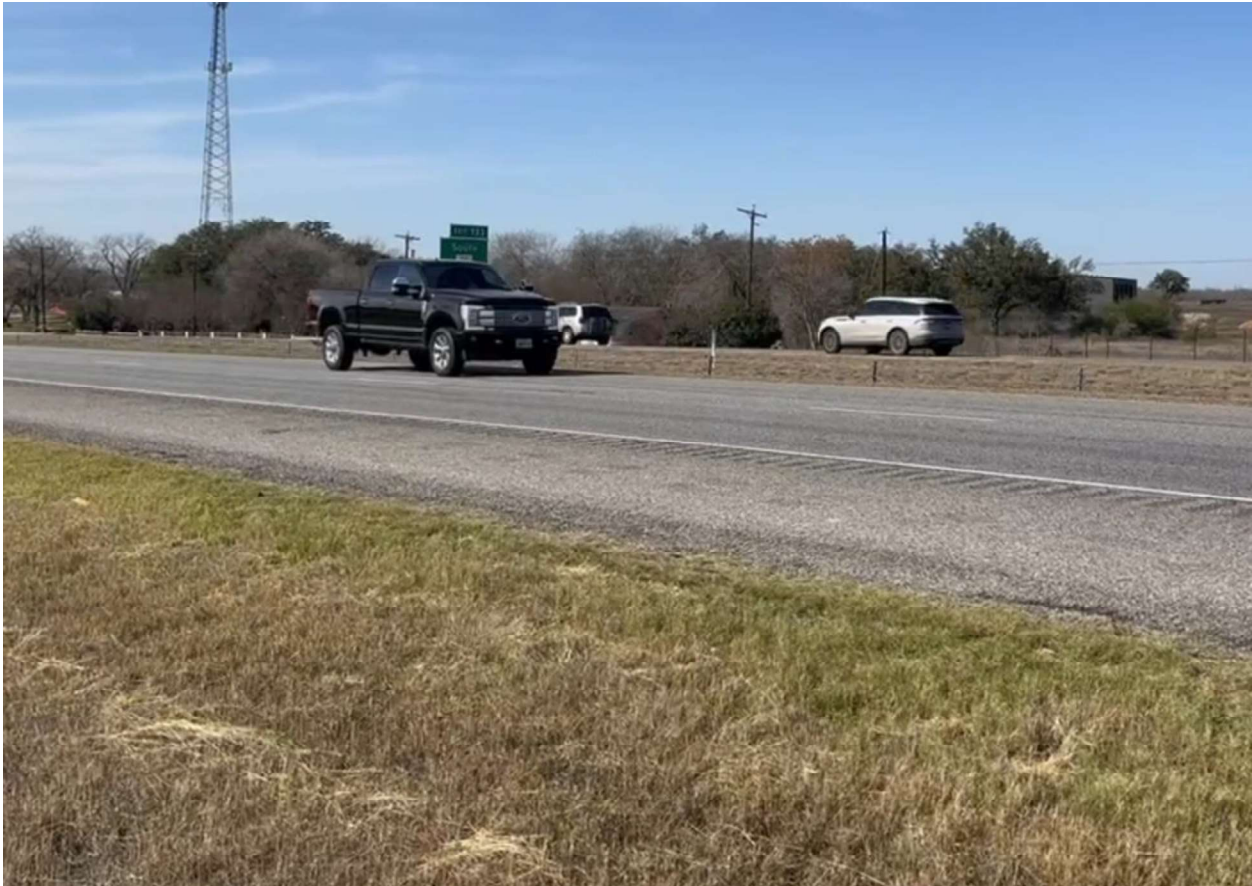
a. Pass 4: View when Mr. Schott's truck is completely in the left travel lane

66. From the location where I estimate that Deputy Babb had been sitting in his patrol car, I could not see when or if the left tires of Mr. Schott's truck hit or crossed the yellow line.

67. I have extensively reviewed and analyzed the footage from Pass 4, 5, and 6. Even after I carefully scrutinized the footage, it is very difficult, if not impossible, to identify where the left tires of Mr. Schott's truck were located in relationship to the yellow line with the naked eye.
